Hybrid Foundation Retrofits

Building America Experts Meeting
Foundations: Research Results and Builder's Handbook Review
November 15, 2011, Minneapolis, MN

This presentation is based research covered in
BSC TO2 7.7 Hybrid Foundation Insulation

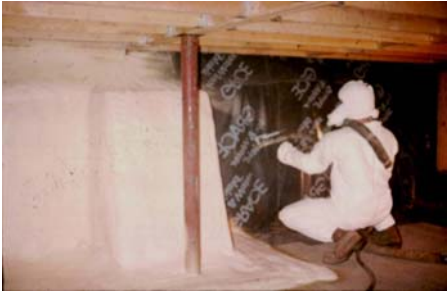
Interior Rubble Retrofit

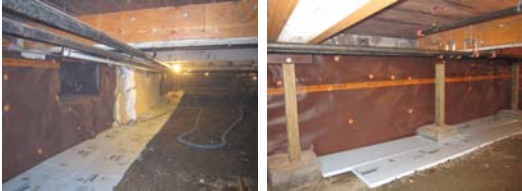
Air Gap Membrane Variant

- Spray foam sufficiently stiff at typ. thickness (2" +)
- XPS basement slab perimeter insulation
- Spray foam forms concrete slab thermal break
- Beam pocket detail (air seal from subslab)

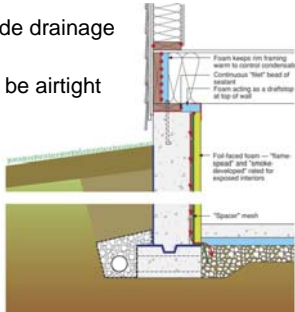
Flat Surface Walls

- Spacer mesh to provide drainage behind foam
- Drainage space must be airtight
- Alternate: XPS with channels and filter fabric

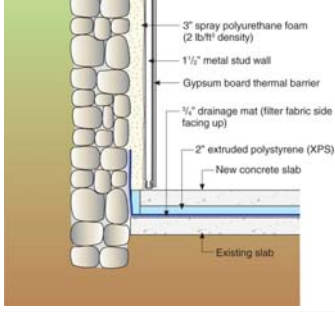
Partial Drainage Detail

- Insulated slab on top of existing slab
- No membrane up wall surface
- Wet vs. dry basement?
- Light gauge steel framing interior wall

Partial Drainage Detail

- Sump must be connected to drainage mesh
- Air leakage around drainage space termination (interior chimney)

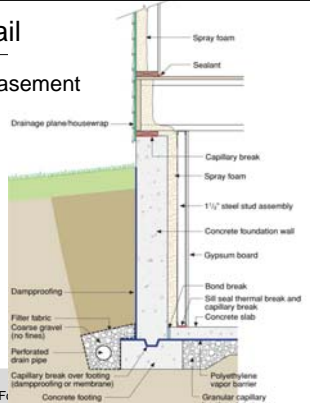
Non-Drained Detail

- "Substantially dry" basement
- Judgment call
- Steel studs clear of spray foam

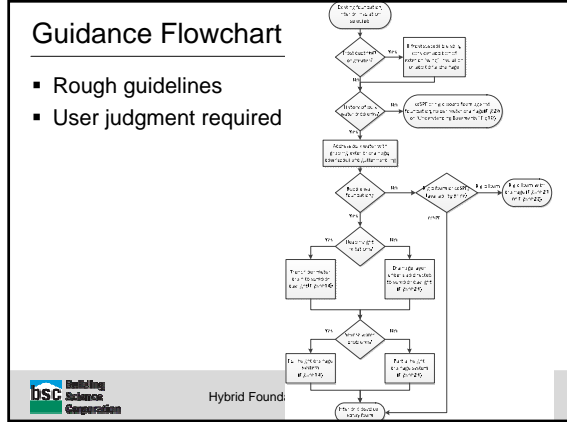
Guidance Flowchart

- Rough guidelines
- User judgment required

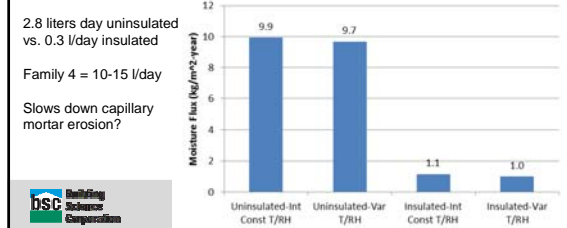
Hygrothermal Simulations

- Moisture emissions before/after interior ccSPF
 - No drainage layer—spray foam only
 - kg/m²·year
 - Constant and variable interior T/RH

2.8 liters day uninsulated vs. 0.3 l/day insulated

Scenario	Moisture Flux (kg/m ² ·year)
Uninsulated-Int Const T/RH	9.9
Uninsulated-Var T/RH	9.7
Insulated-Int Const T/RH	1.1
Insulated-Var T/RH	1.0

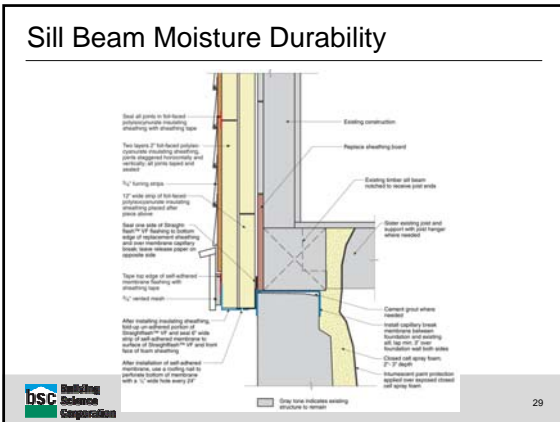
Sill Beam Moisture Durability

- Sill-to-foundation surface colder
- Less drying available
- But greater protection from bulk water
- Permeable insulation detail?
