**Super Insulated Walls and Moisture:
Does Bad Stuff Happen?**
Course Number

Chris Corson and Kohta Ueno
March 4, 2015

Super Insulated Walls and Moisture: Does Bad Stuff Happen? (Double Stud)

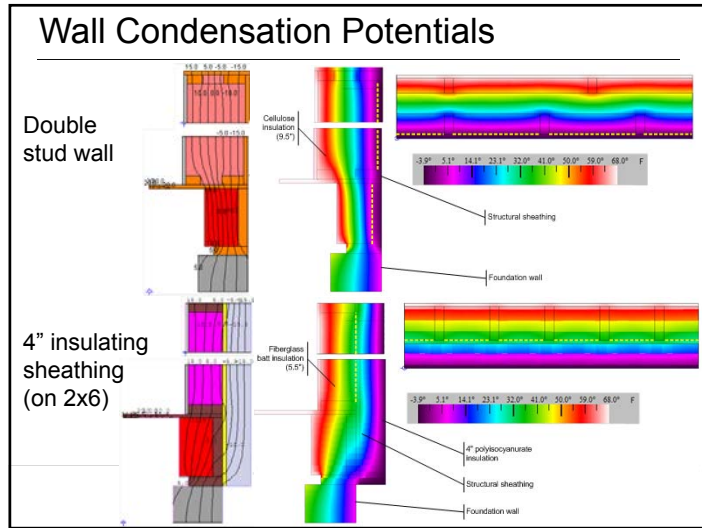
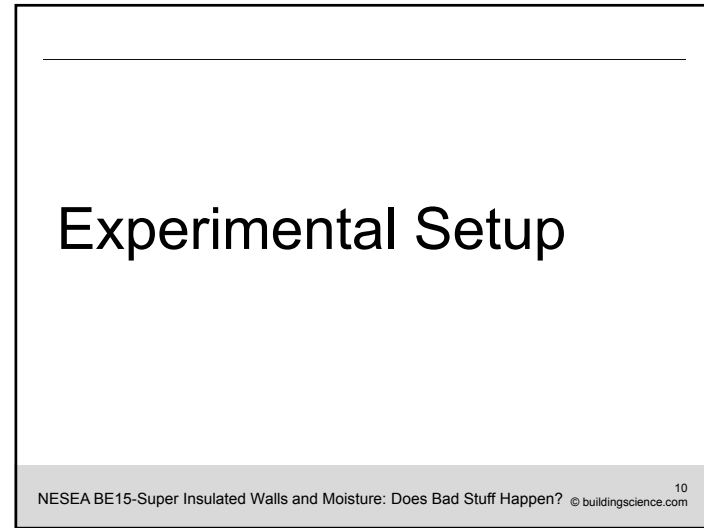
Wall Construction

- Vinyl siding
- ZIP wall sheathing (OSB)
- 12" ocSPF, double stud
 - Considering cellulose
- Class III vapor control (latex paint) on GWB

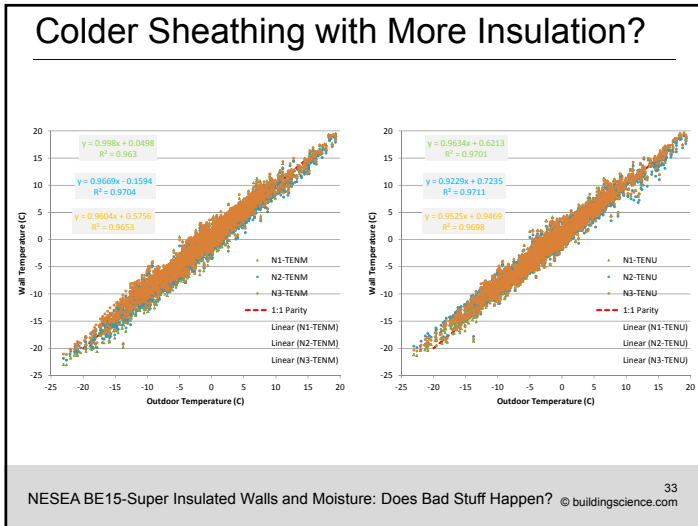
48.0°F
ε=0.90
FLIR

- Outdoor temperature 50 F (10:30 AM)

- ### Colder Sheathing with More Insulation?
- Double stud wall sheathing maybe ~1 F or less colder at coldest conditions
 - Steady state analysis predicts 0.8 F difference @ 7 F outdoors
 - Wintertime energy/Btu's through sheathing possibly more important (drying energy): doubling insulation = halving heat flow
 - 12" vs. 5.5" cavity insulation different than cavity vs. exterior insulation!
- NESEA BE15-Super Insulated Walls and Moisture: Does Bad Stuff Happen? © buildingscience.com 34

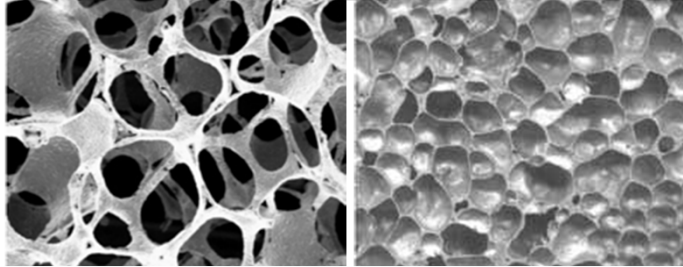
ocSPF Protective Mechanisms

Open-cell SPF Images c/o SPFA Closed-cell SPF

- Food science literature—oxygen needs to be in PPM range before inhibiting mold growth. Mold can get oxygen from substrate.
